Photos 44-49: Port Edward Cannery Museum, Mile ~81.9. 14 October 2017

Photos 50-51: Port Edward Boat Launch, Mile ~86. 14 October 2017

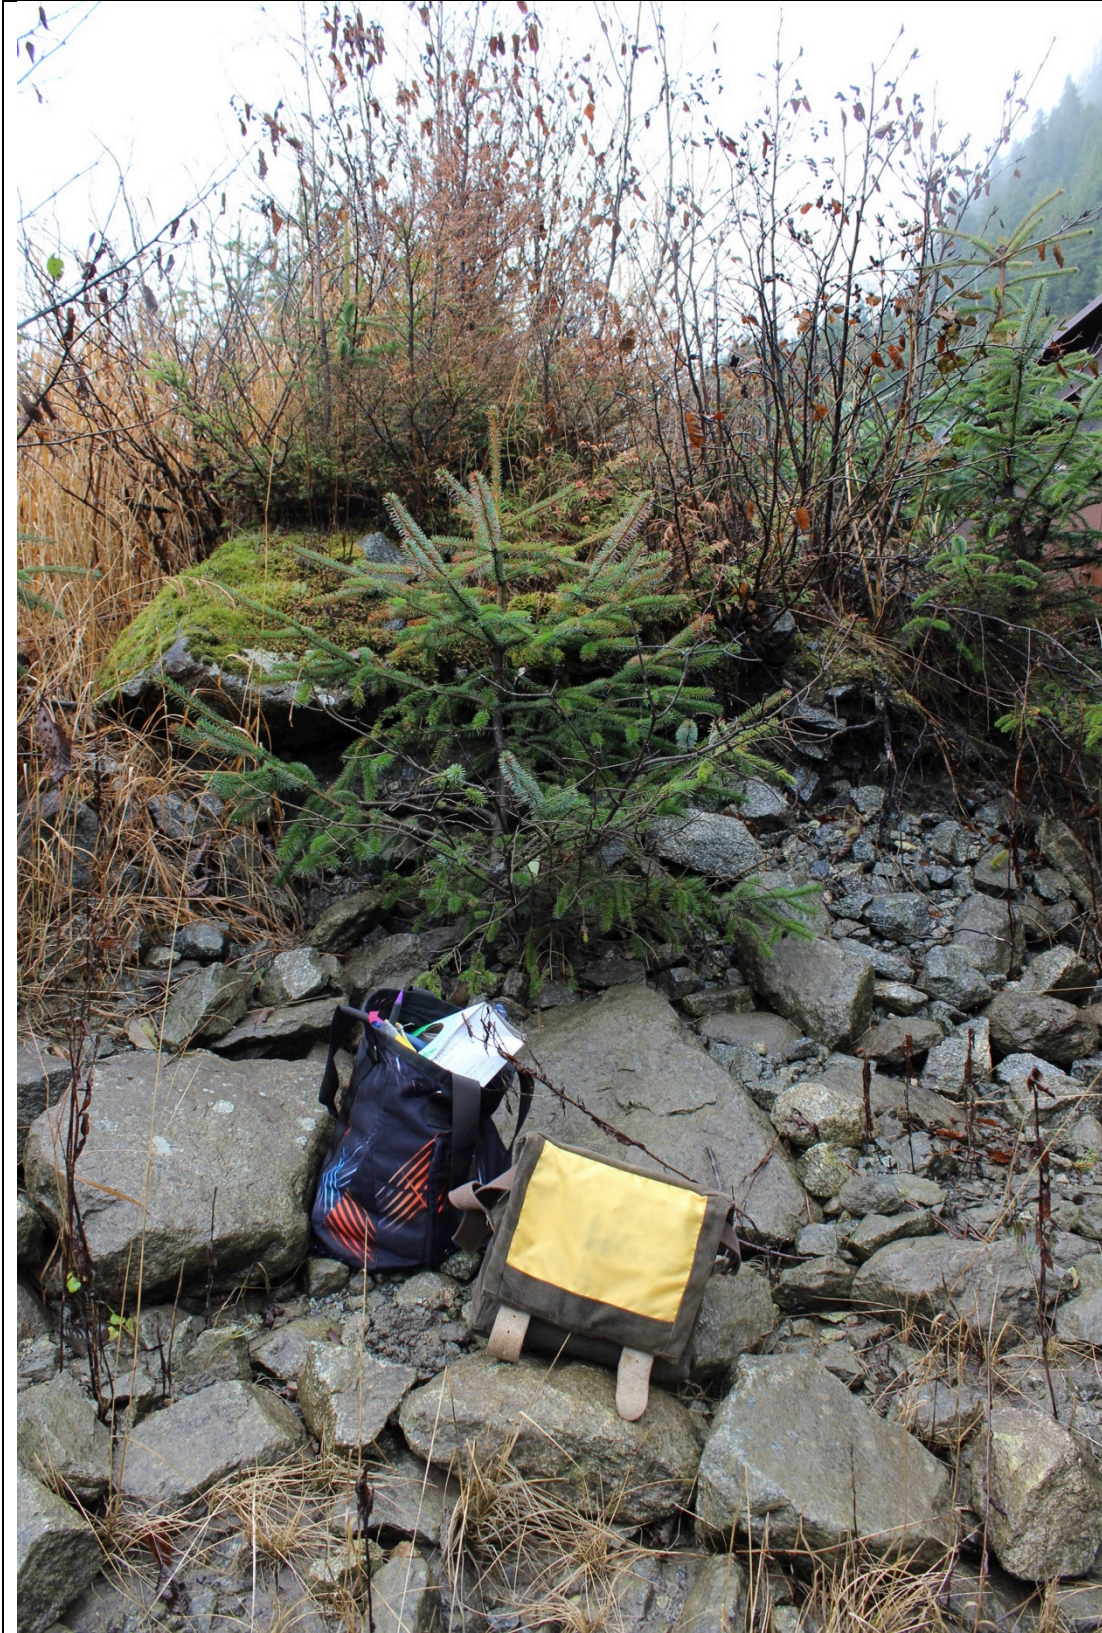
Photo 42. Damaged Sitka spruce at HWM.

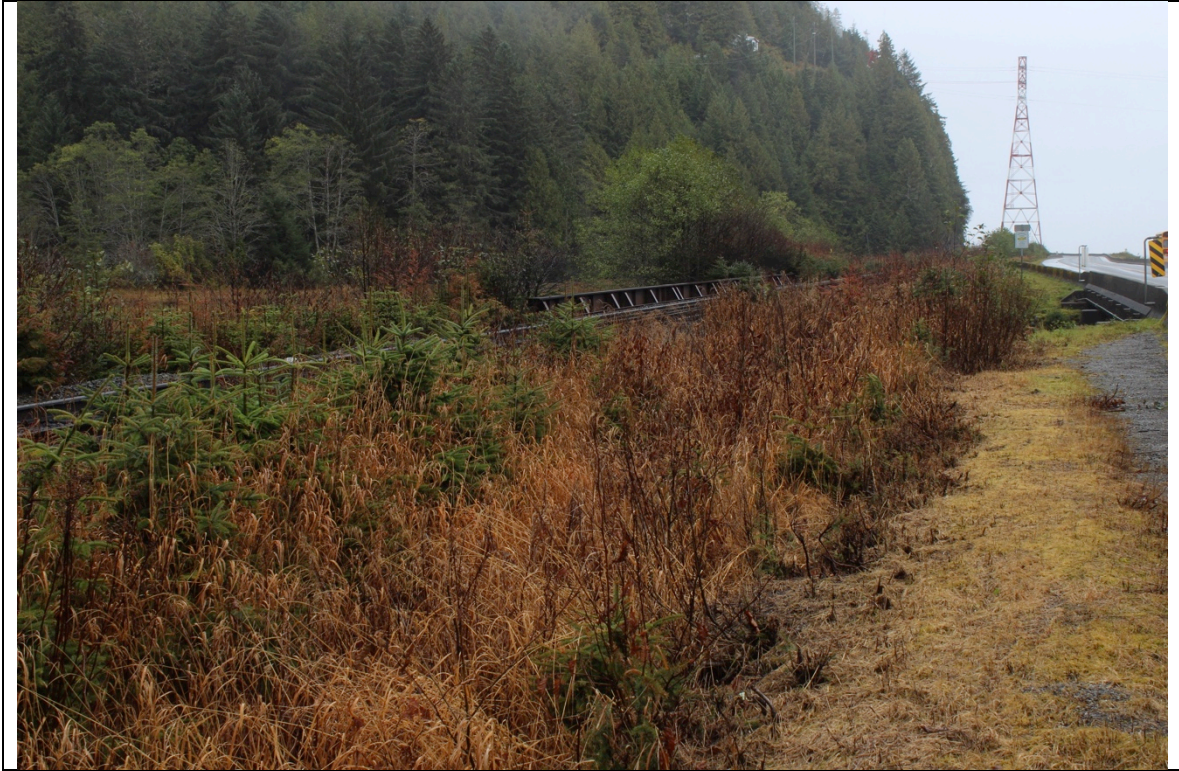
Photo 43. Eastbound view over creek, showing damaged conifers, shrubs and herbaceous species along CN right-of-way.

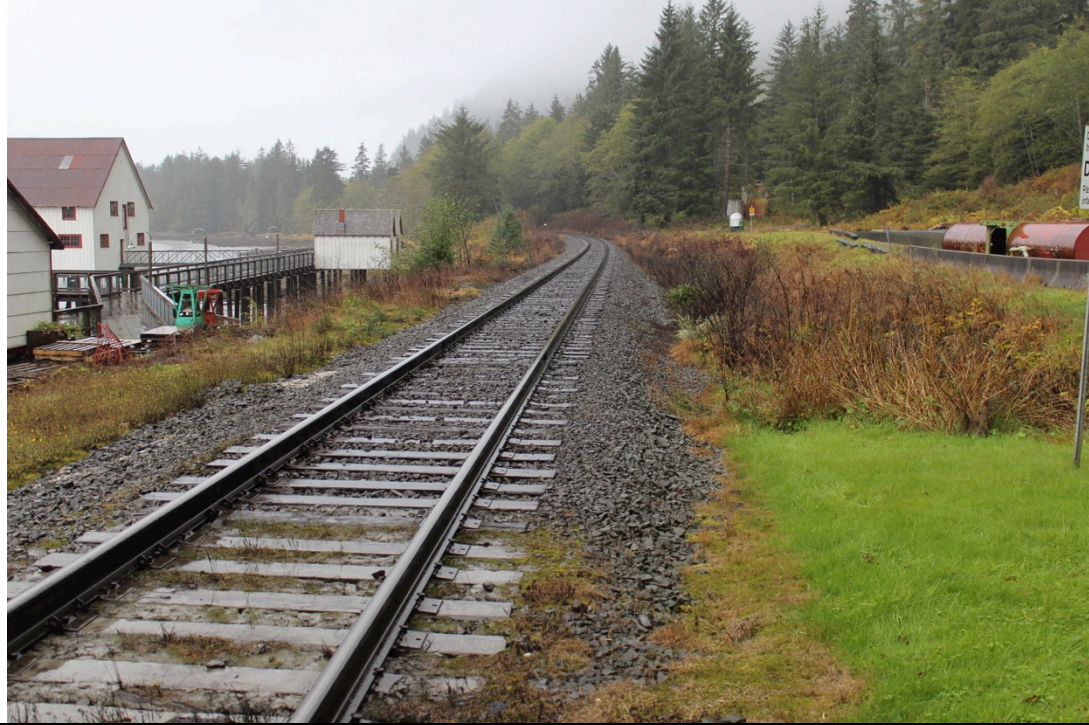
Photo 44. Westbound view, showing damaged vegetation on right (over ditched watercourse beyond lawn) and on left (adjacent Inverness Passage, Skeena River).

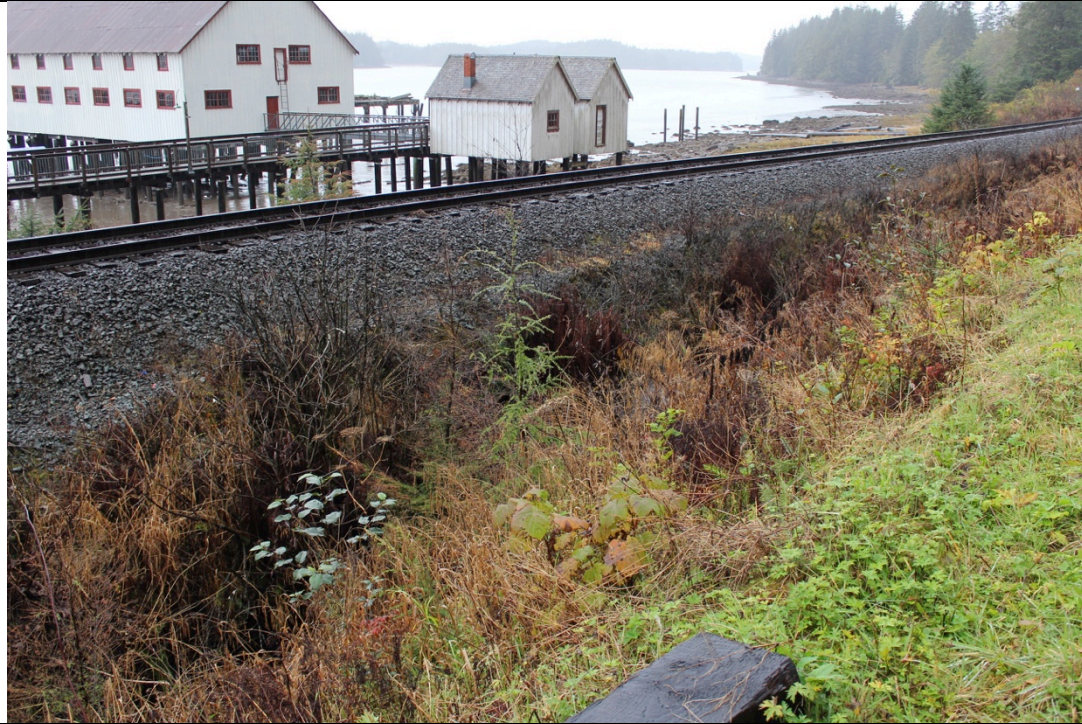
Photo 45. View of ditched channel with heavily damaged vegetation, bank to bank.

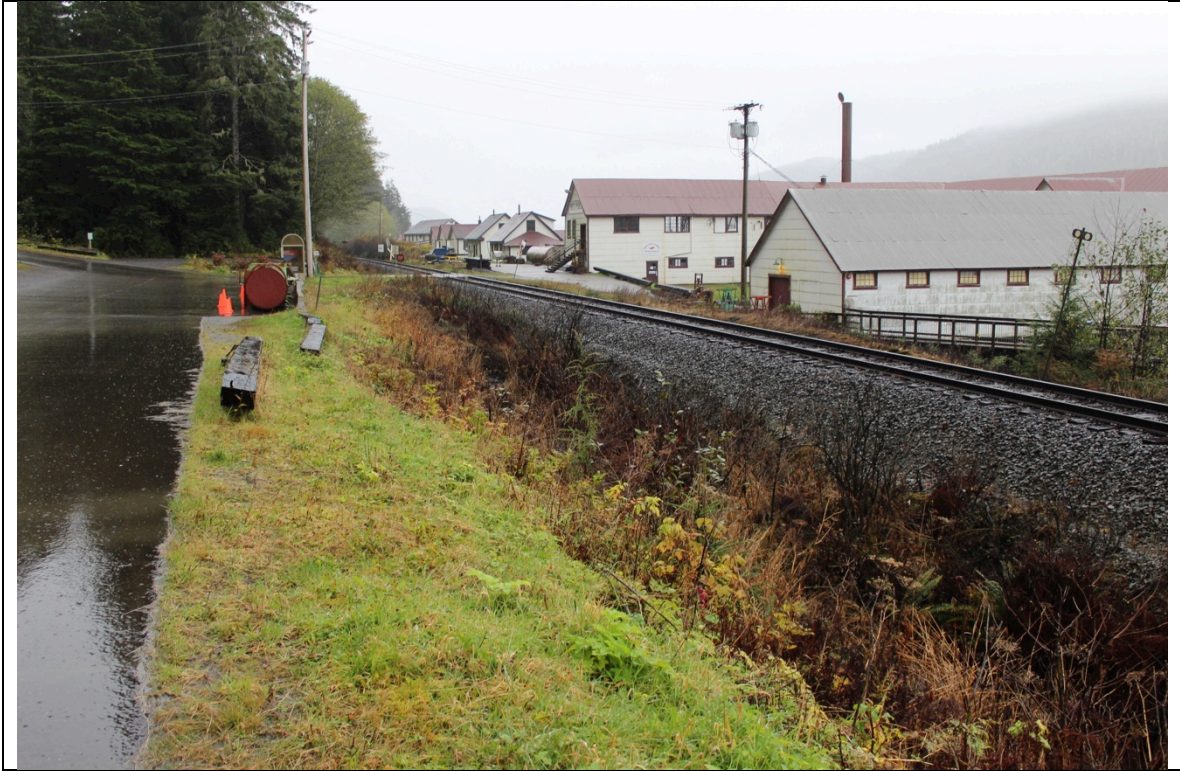
Photo 46. Downstream view of ditched watercourse, showing heavy damage across channel.

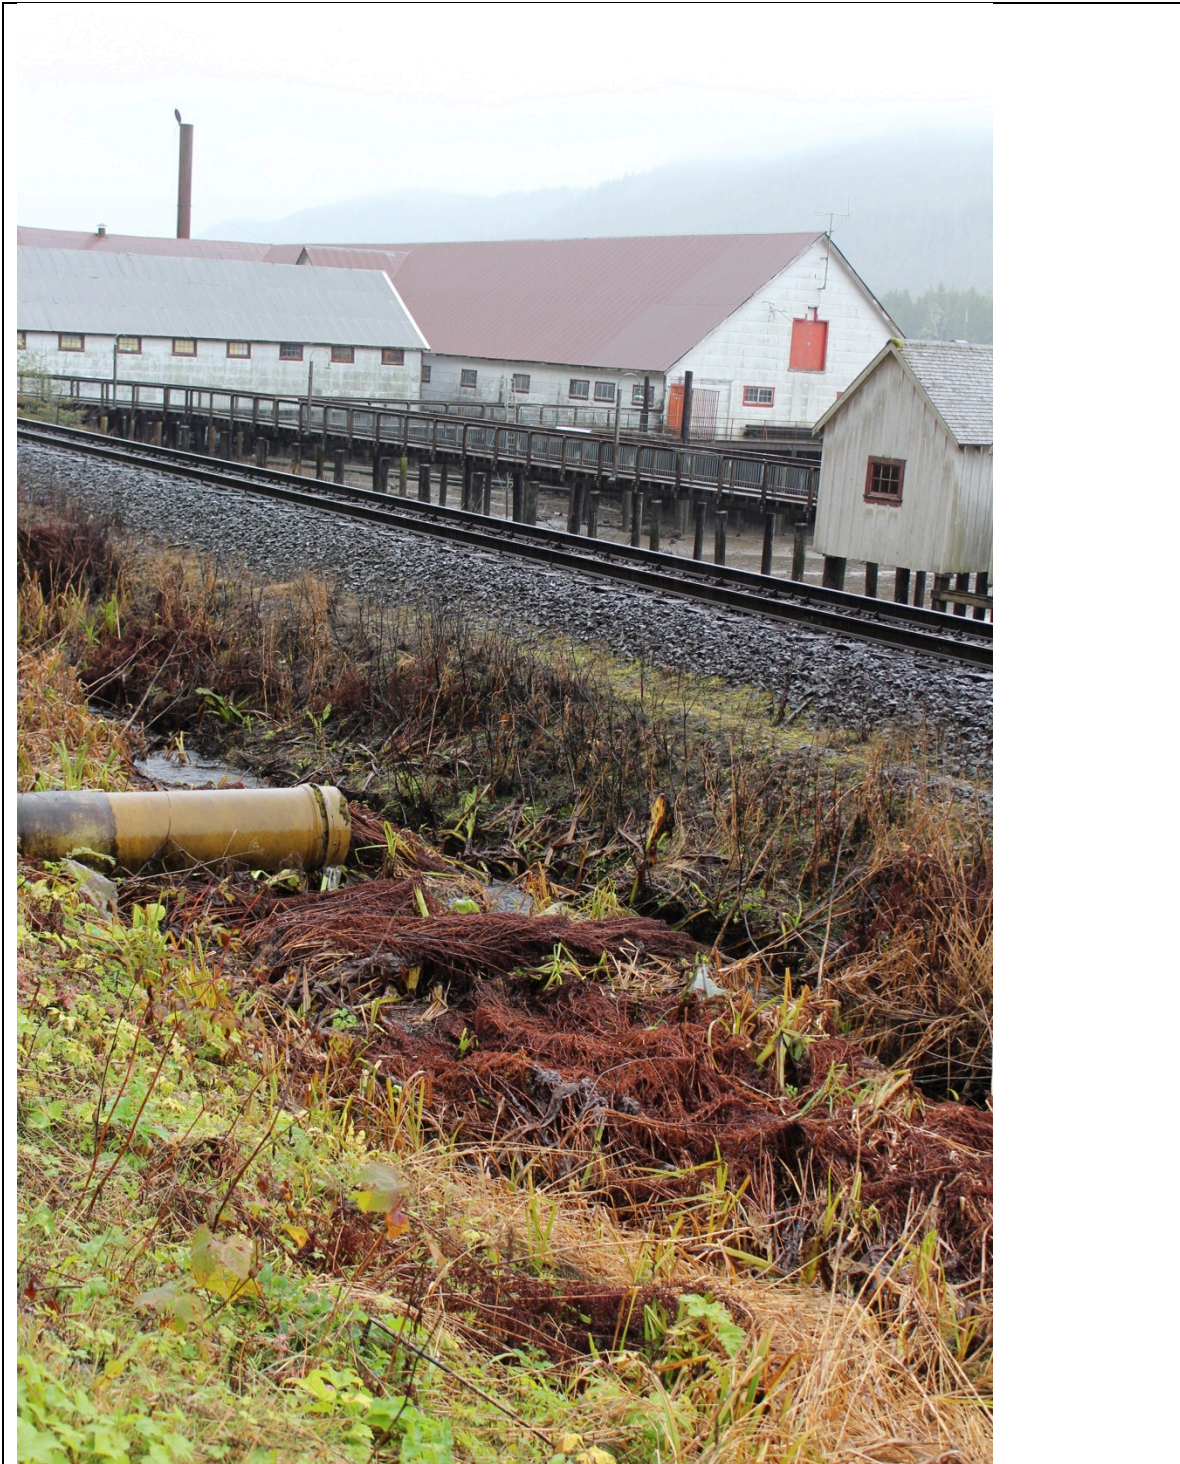
Photo 47. Downstream view of ditched channel with stormwater drain outlet.

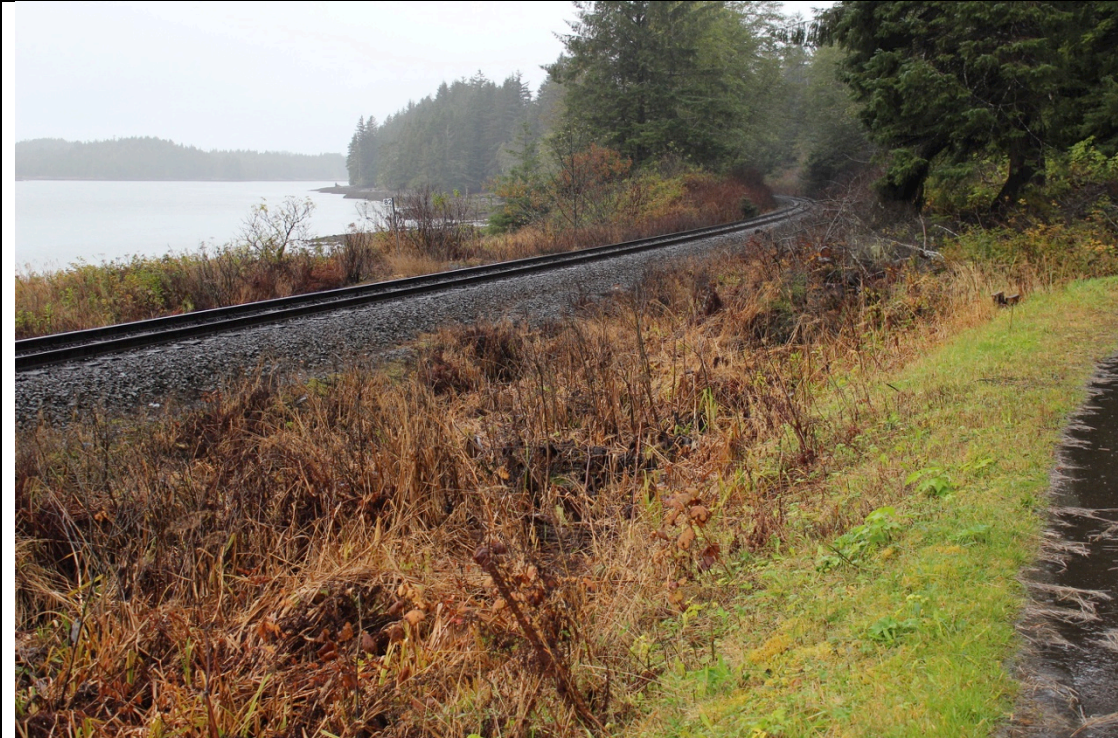
Photo 48: Westbound view, showing damage over ditched channel and adjacent Inverness Passage.

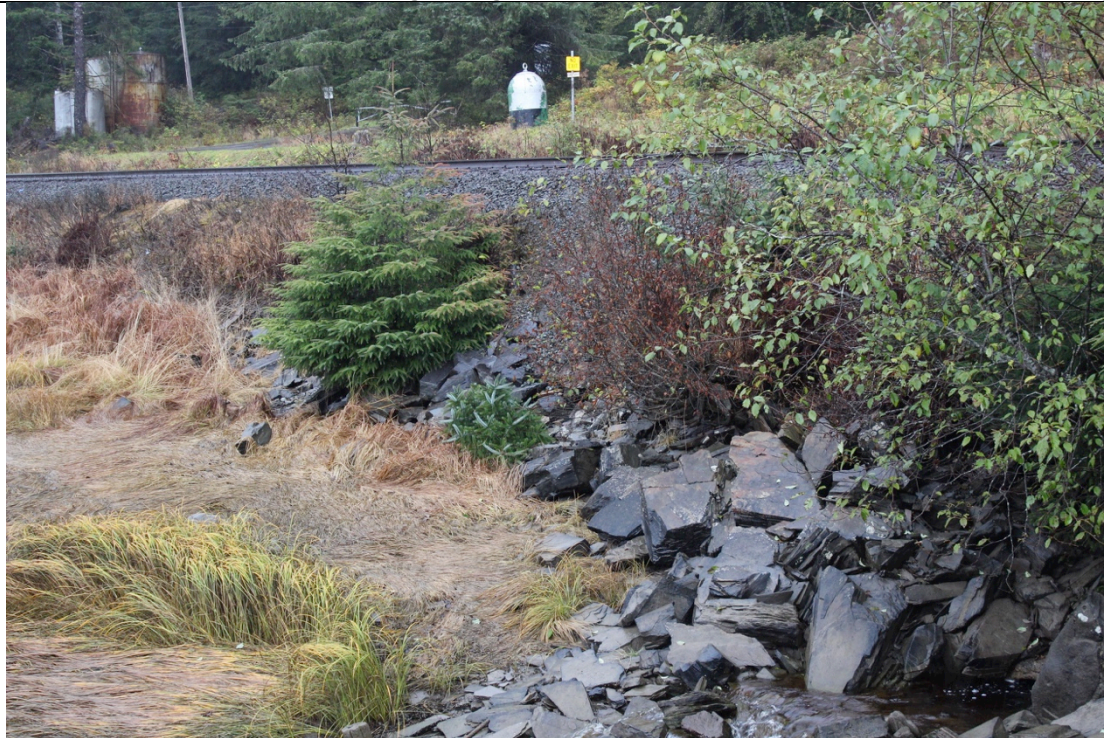
Photo 49. View of Inverness Passage (Skeena estuarine habitat) below CN right-of-way, showing damaged red alder, western hemlock and herbaceous vegetation at the tidal HWM.

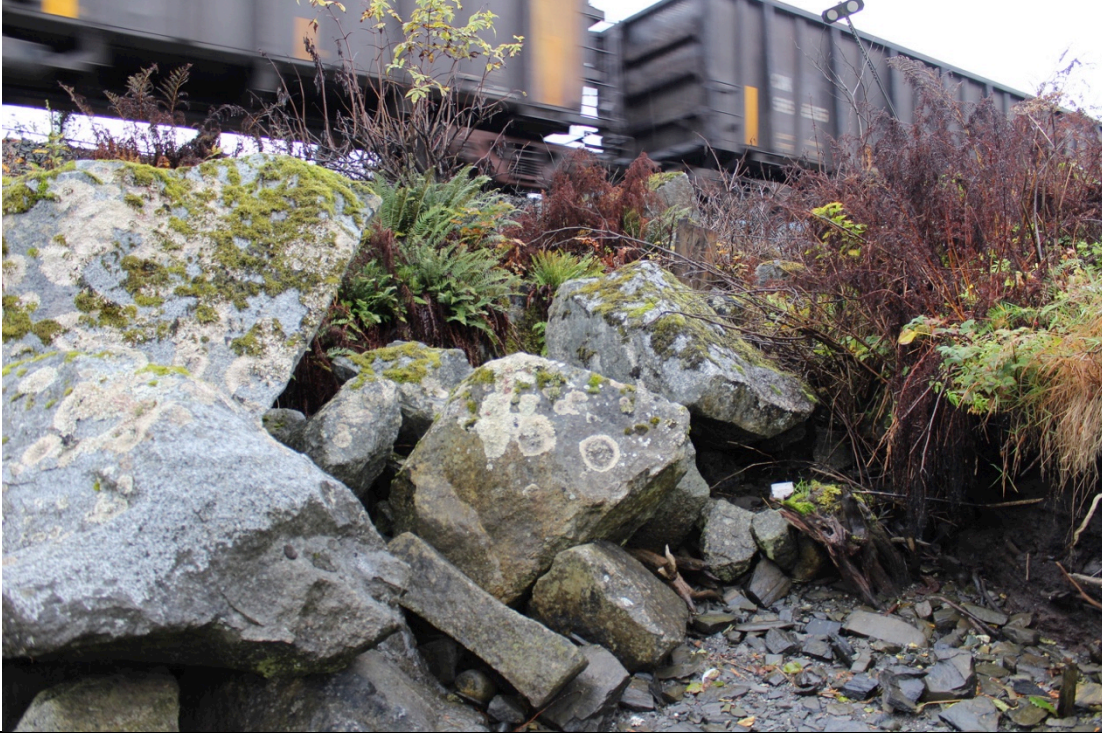
Photo 50. Damaged red elderberry, salmonberry and ferns at HWM.

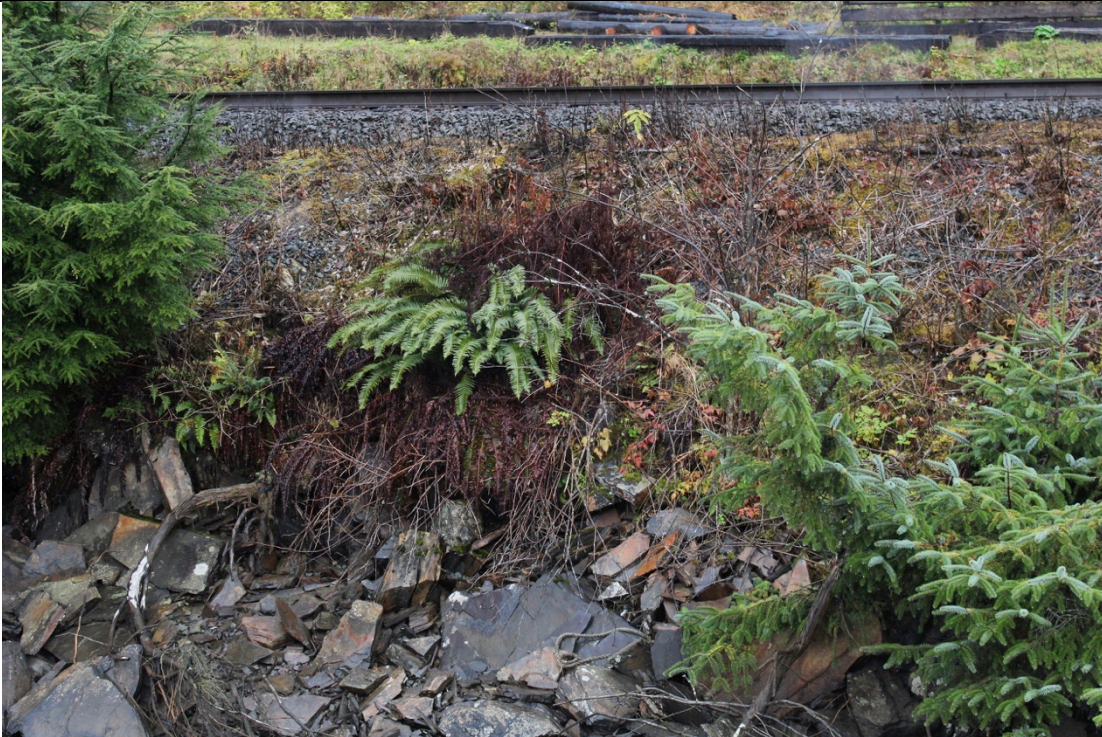
Photo 51. Damaged vegetation adjacent to Inverness Passage (Skeena River estuary).
