Photos 32-33: Basalt Creek, Mile 60. 14 October 2017

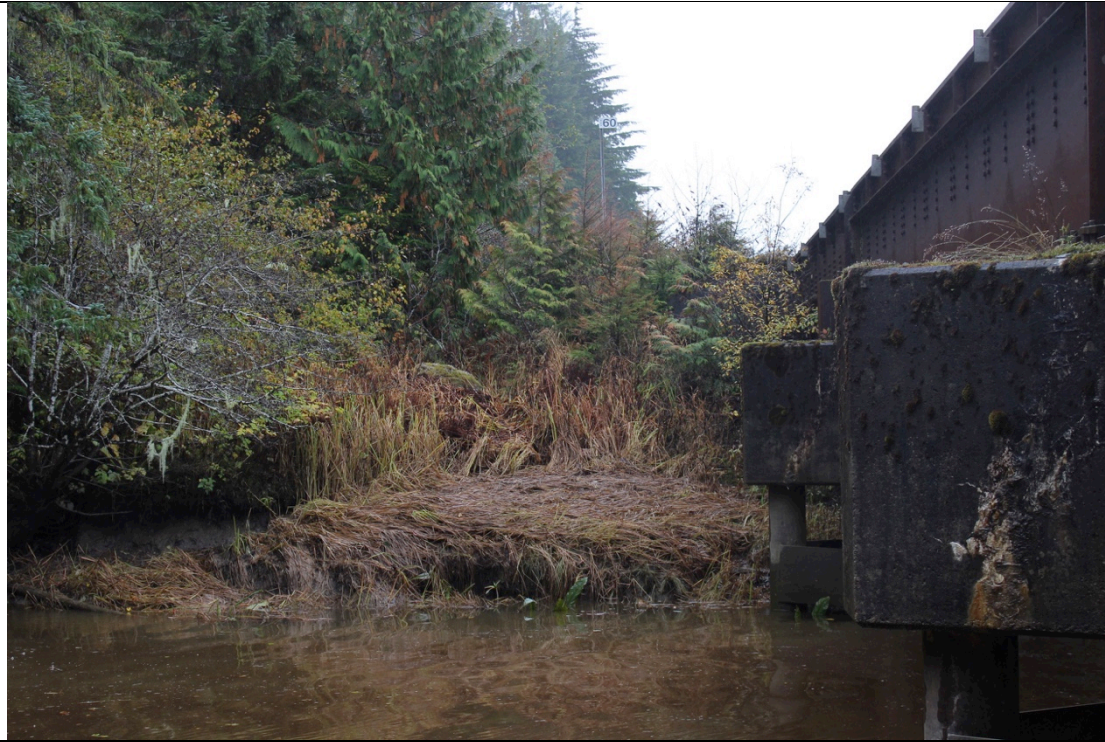
Photo 32. View across to upstream left bank, showing damage to conifers above rail bridge abutment.

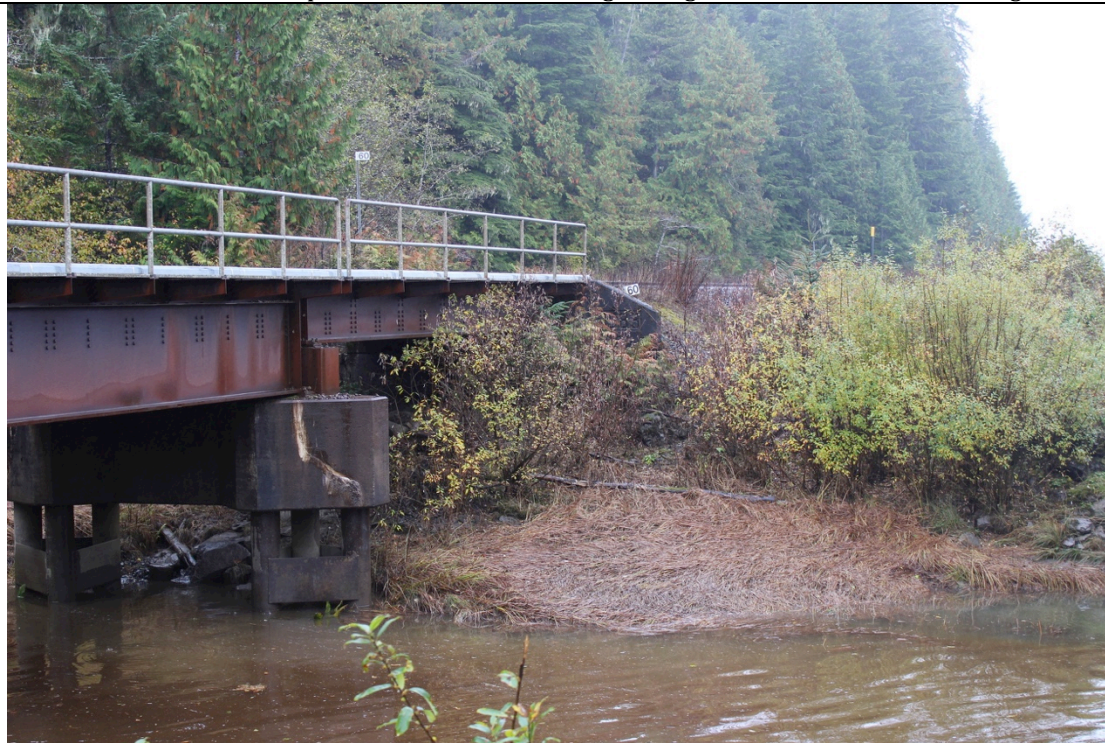
Photo 33. View across to left bank downstream of rail bridge: note damage to Sitka willow and cedar shrubs below bridge abutments, above high water mark (tidal).

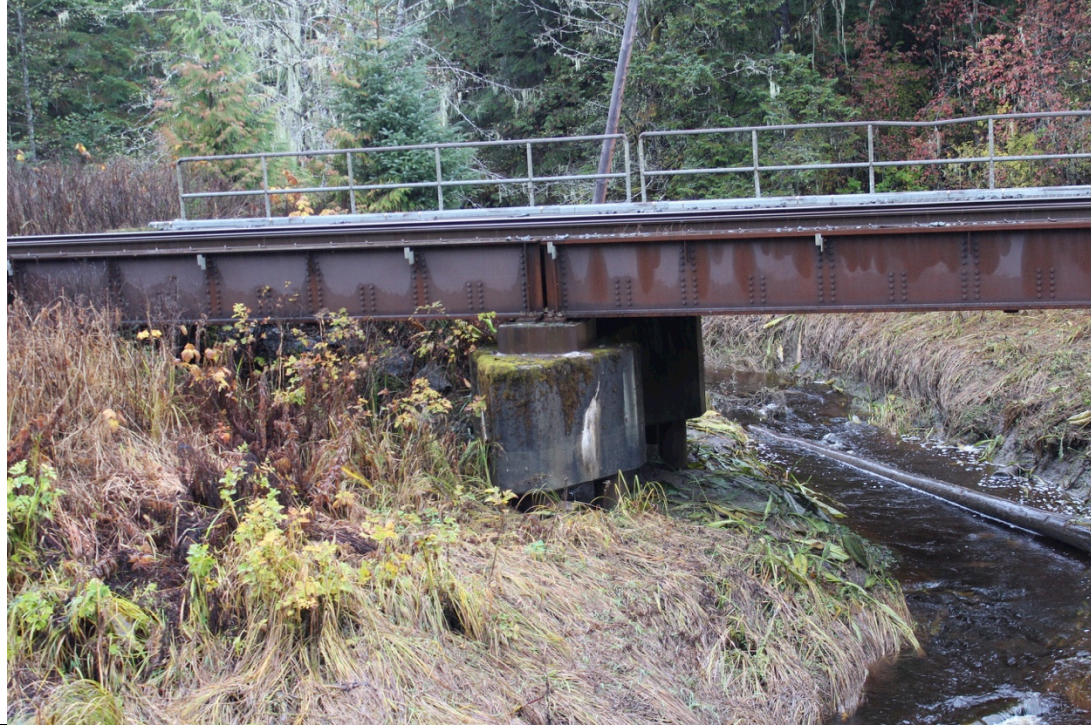
Photo 34. Upstream view, showing defoliation and foliar damage on various species on right bank. Note tidal wetland above stream channel, indicating a high water mark above the level of the channel banks.

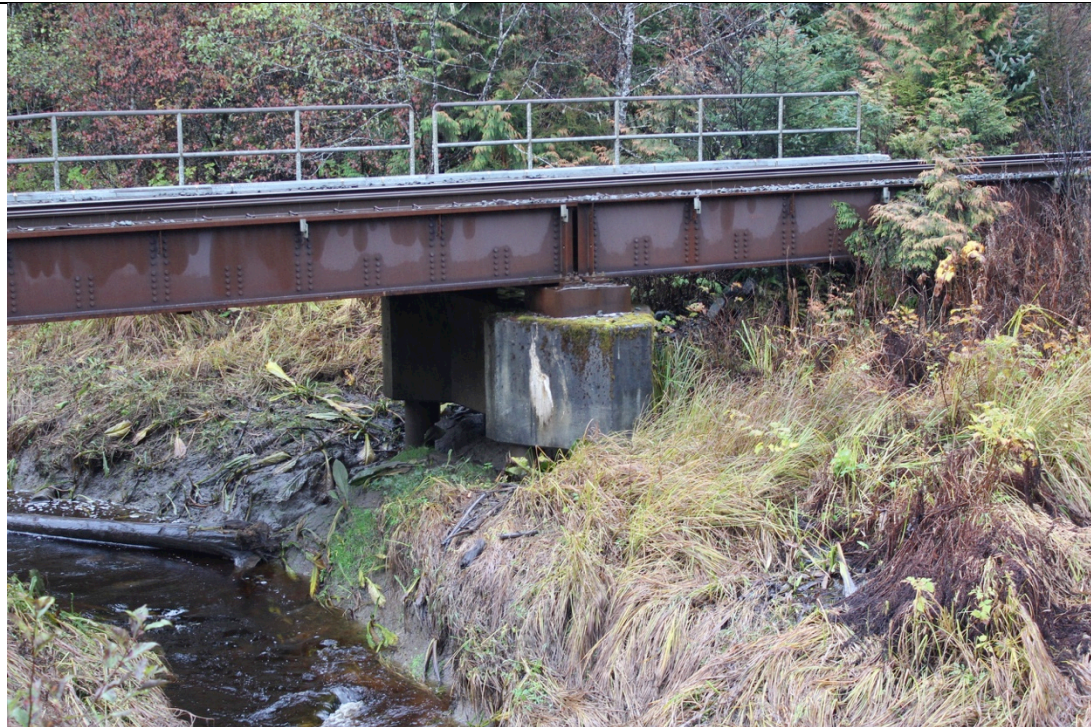
Photo 35. Upstream view of left bank, showing damaged cedar and various species below rail bridge abutments.

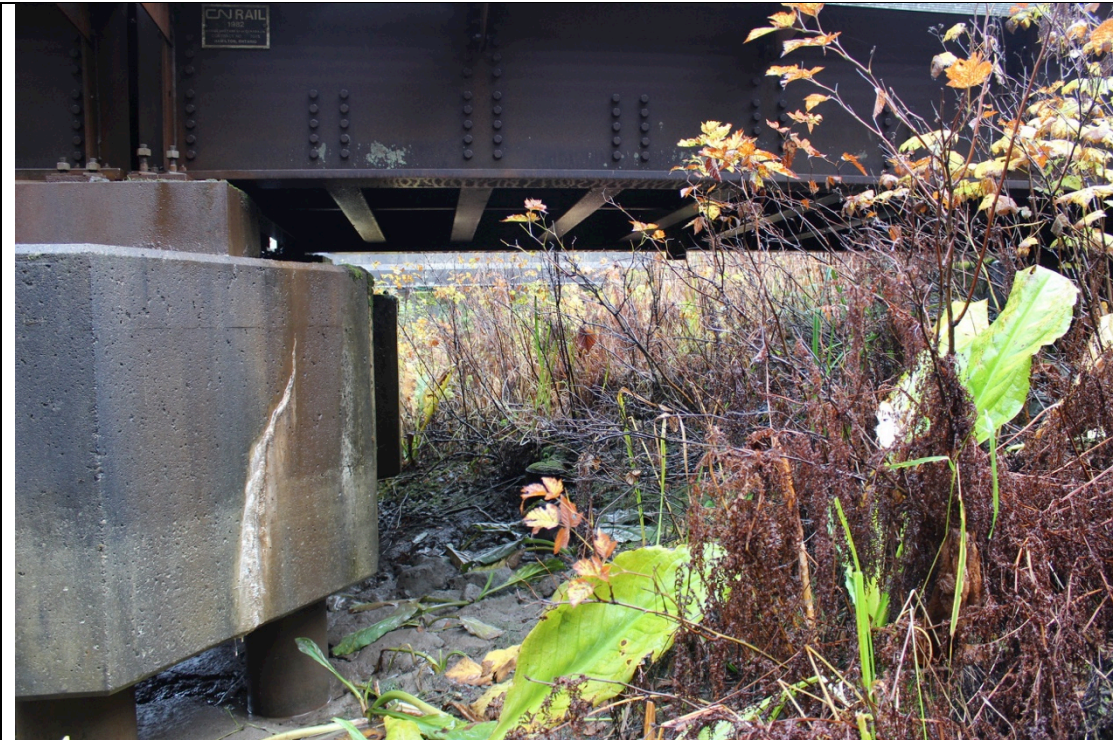
Photo 37. Downstream view of right bank, beneath rail bridge, showing damaged salmonberry and ferns at edge of/overhanging high water mark.

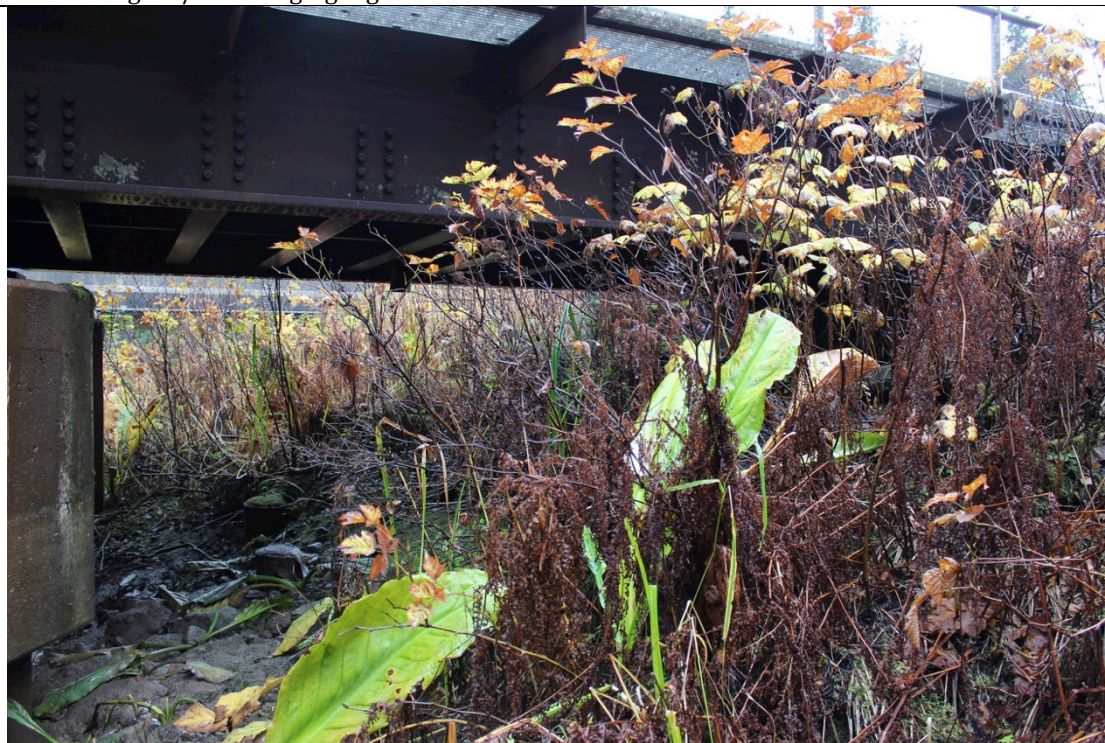
Photo 38. View under rail bridge, towards Skeena River, showing foliar damage to ferns and salmonberry.

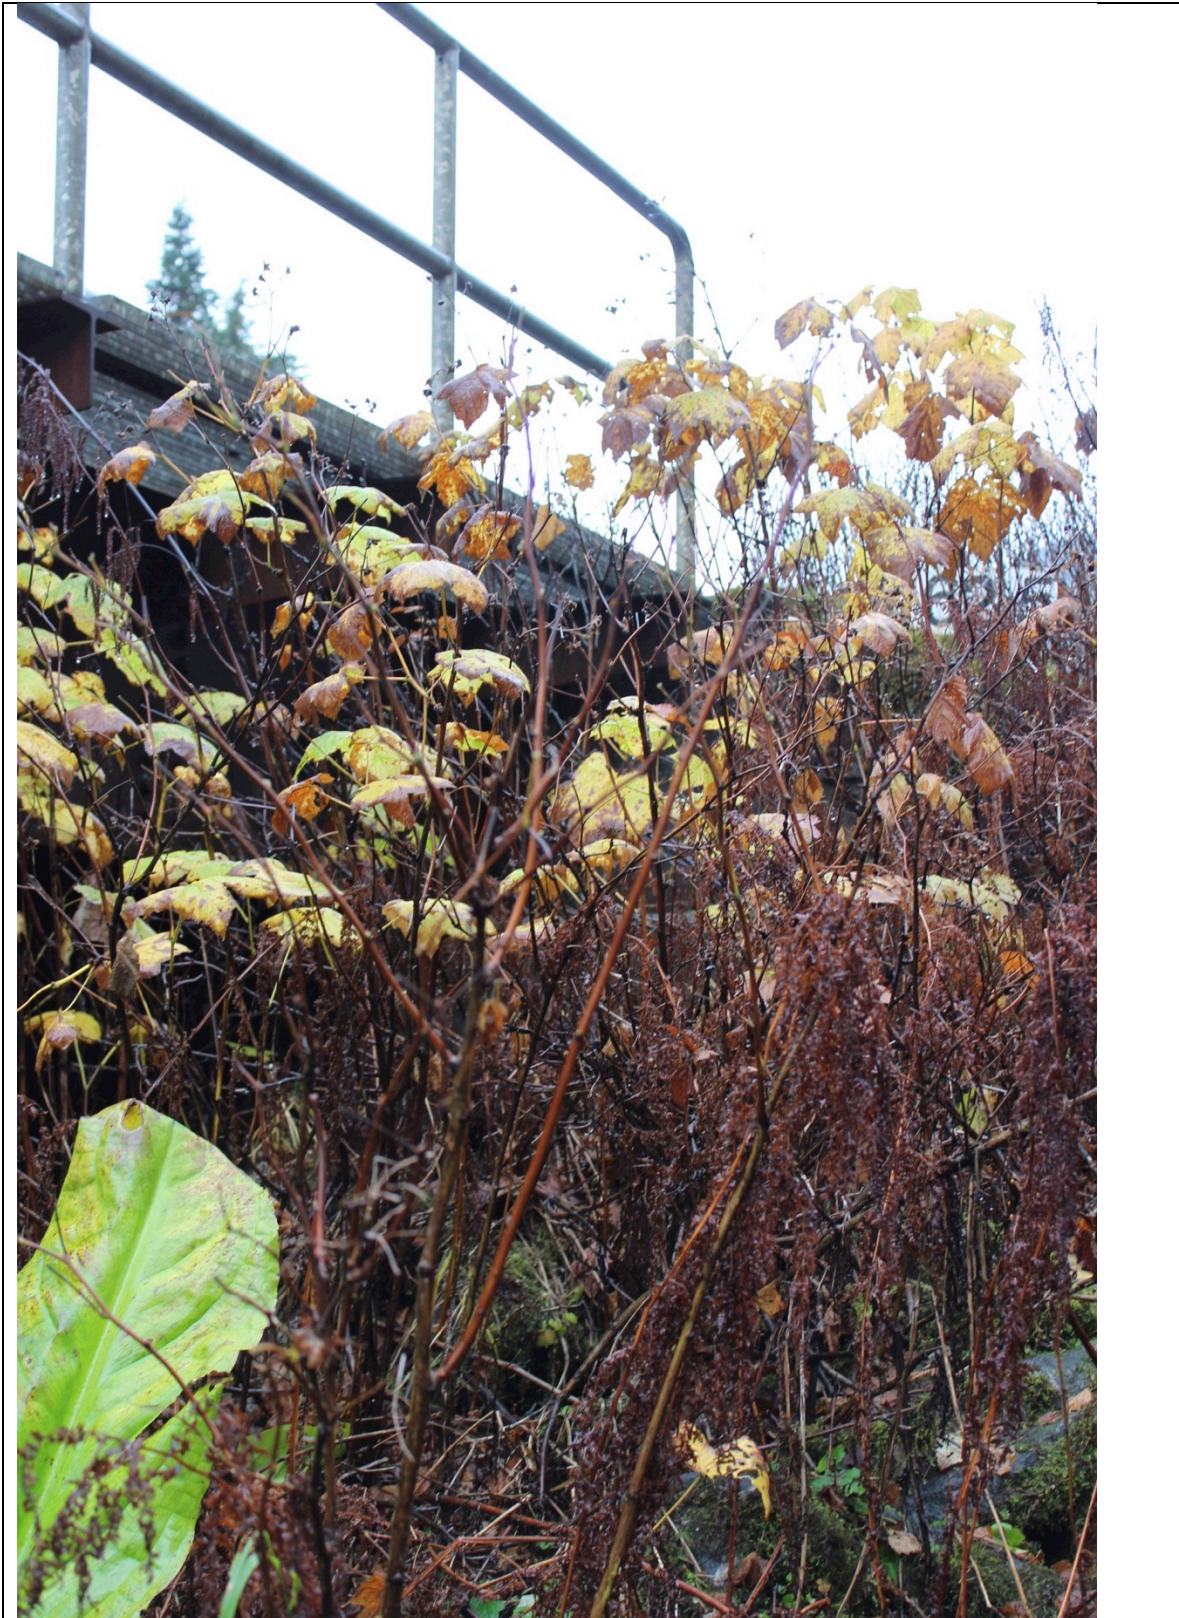
Photo 39. View up right bank, to edge of rail bridge abutment, showing damaged thimbleberry, goatsbeard, salmonberry and fern species.

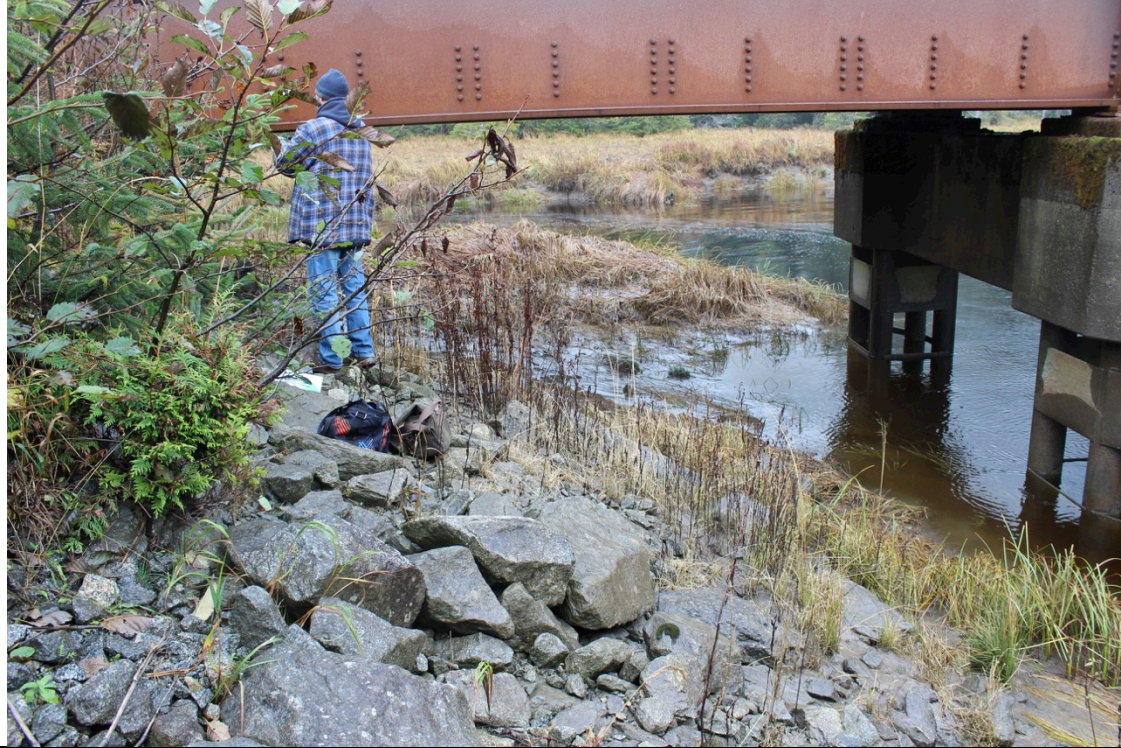
Photo 40. Upstream view showing damaged herbaceous vegetation below the HWM, and damaged red alder, spruce and Western redcedar overhanging channel.

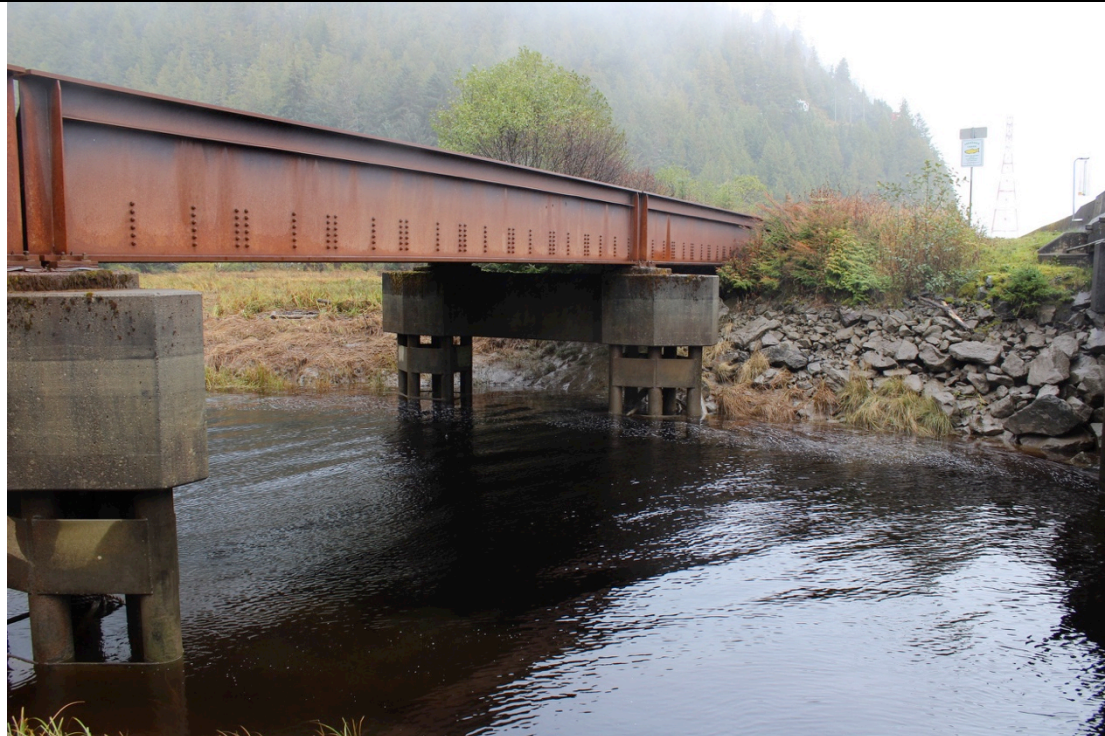
Photo 41. View to left bank showing damage to conifer shrubs on downstream abutment; note extensive wetland (tidal influence) upstream of rail bridge.
