## Attachment 2: Photo Document (Part 1: Pages 1-15)

Field Assessment Report and Background Review  
CN 2017 Herbicide Application in the Skeena Sub,  
Terrace to Prince Rupert, BC

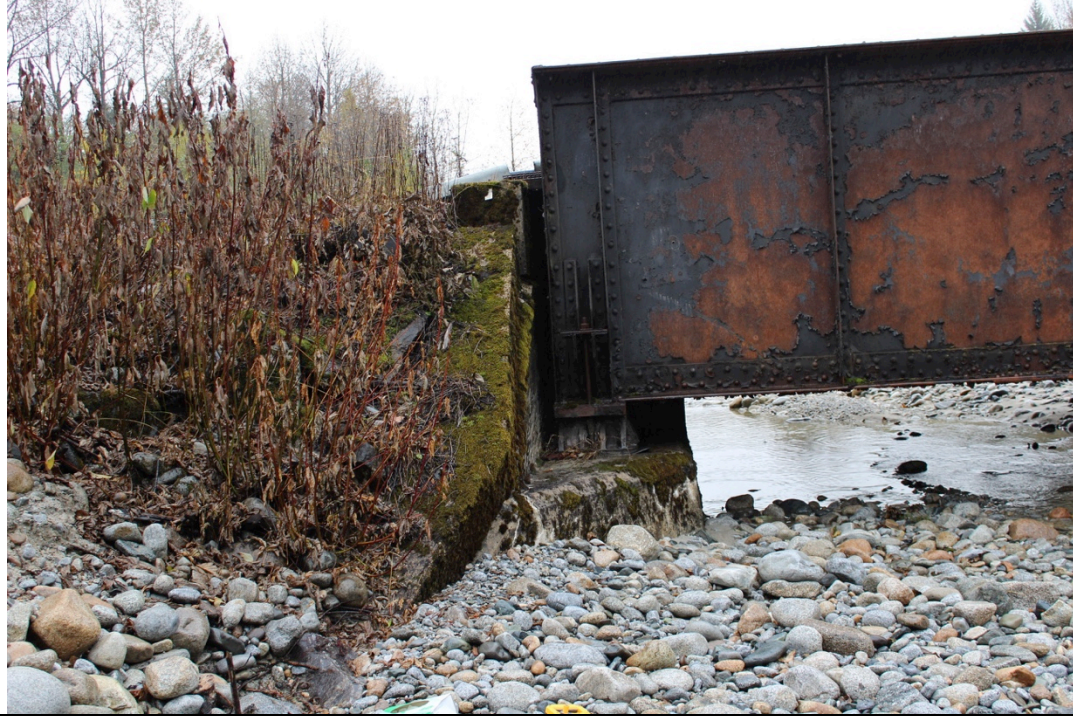
**Photos 1-2: Shames River, Mile ~15.5. 14 October 2017.**

Photo 1. Upstream view, left bank; note damaged red osier dogwood over channel.

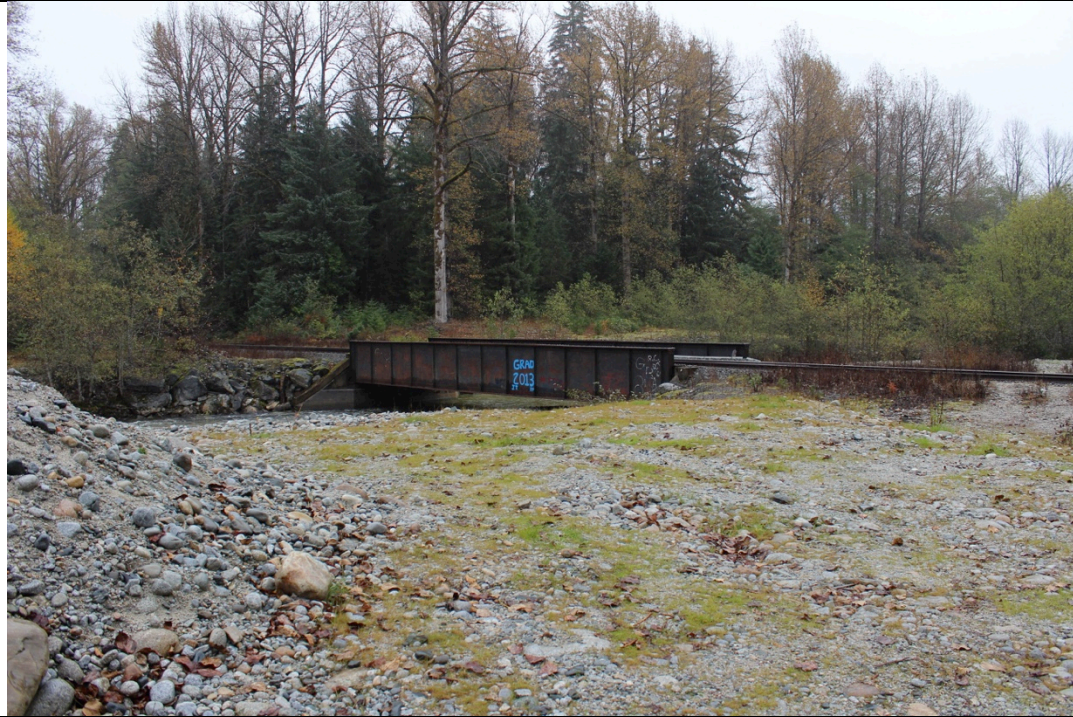
Photo 2. View across to left bank; note damaged vegetation evident up to rail bridge abutments on both banks.

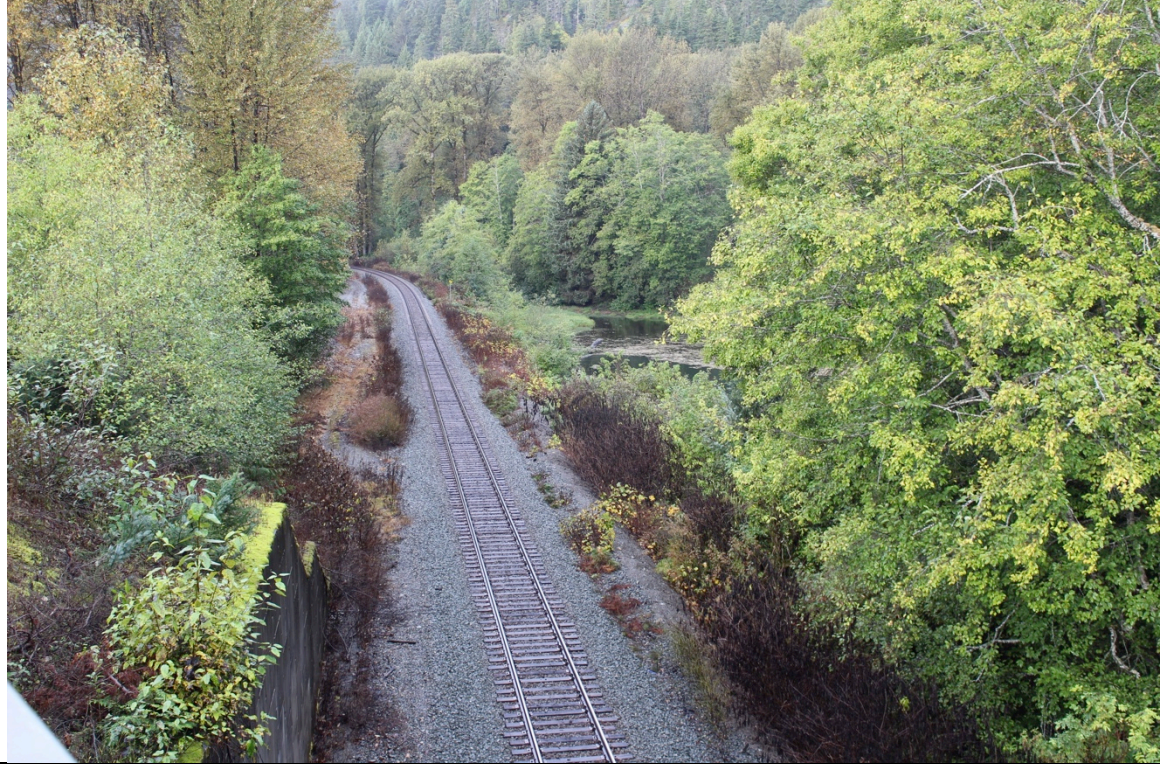
**Photo 3: Mile ~20.5, taken from Esker overpass. 14 October 2017.**

**Photo 3: Downstream view of high-value rearing area in off-channel habitat of the Skeena River.**

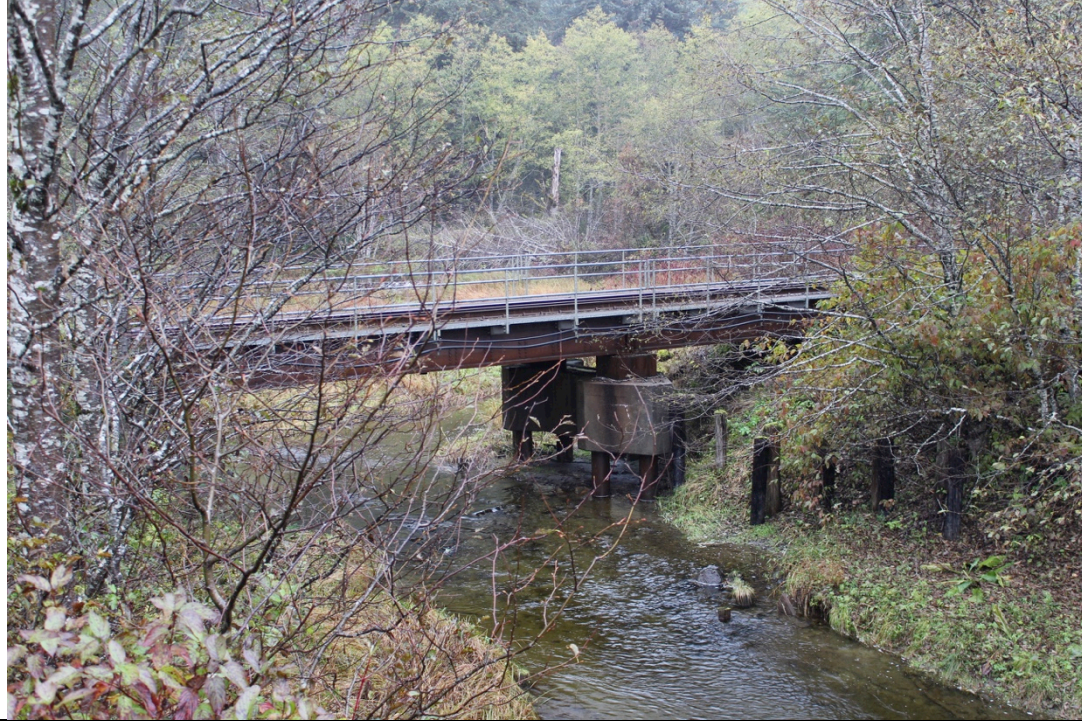
**Photos 4-6: Polymar Creek, Mile ~43. 14 October 2017.**

Photo 4. Upstream view to right bank; note wetland area that continues to east below rail bridge.

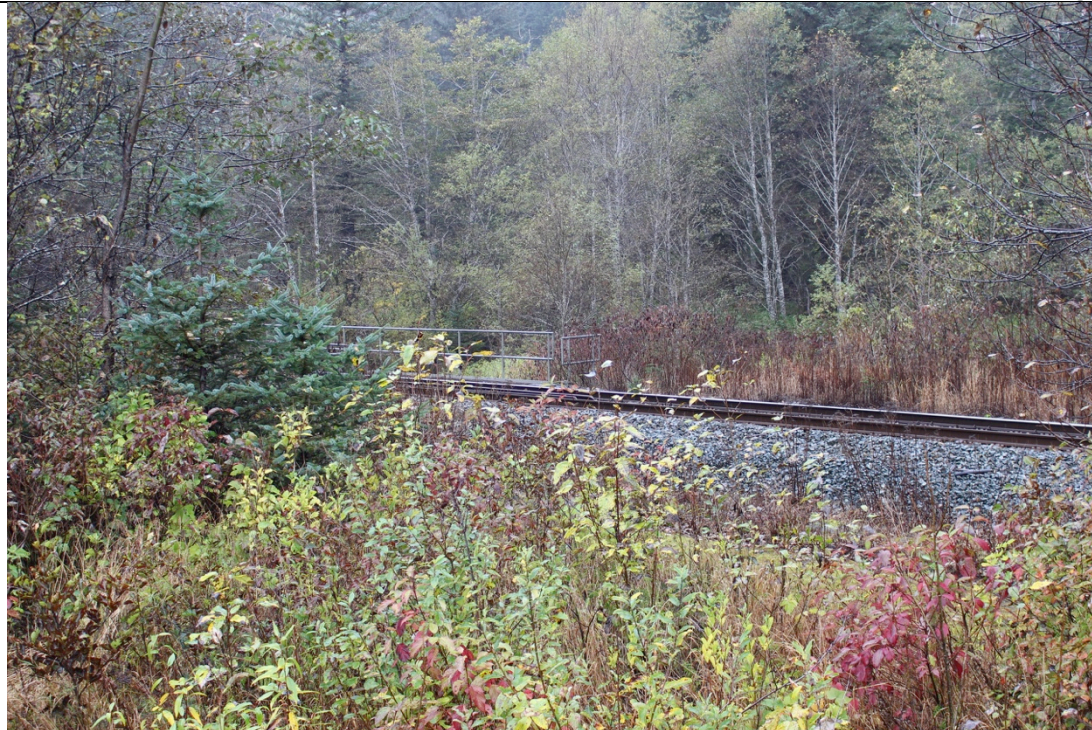
Photo 5. View to northwest; note defoliated red osier dogwood at rail bridge abutment, and wetland area beyond.

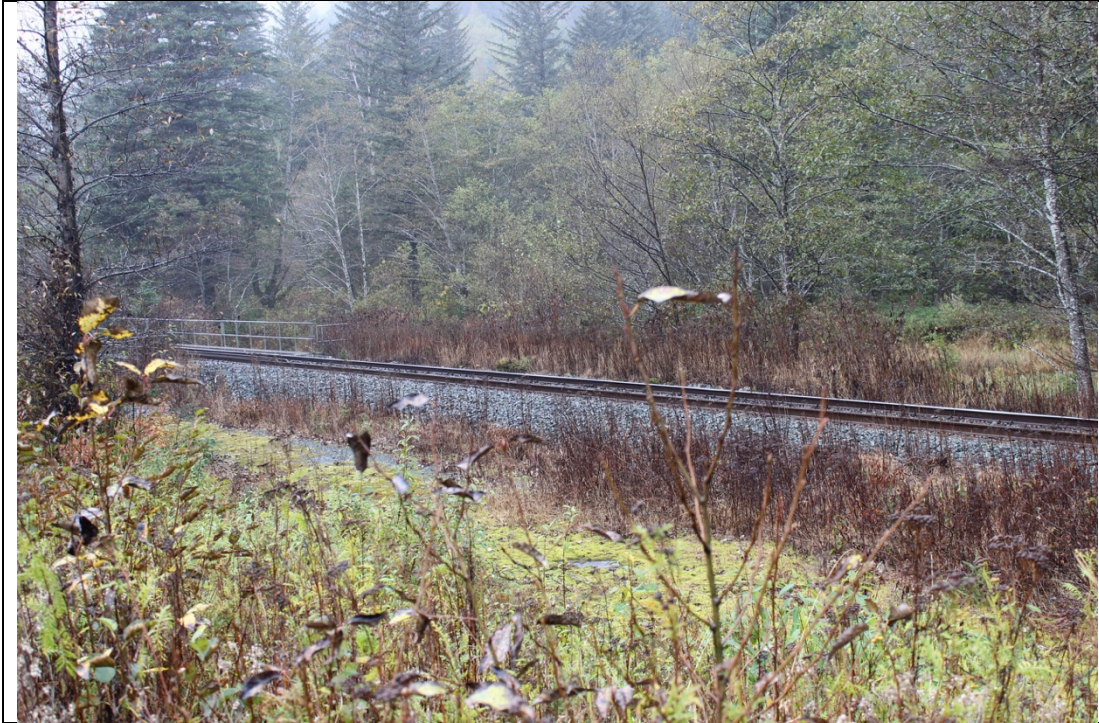
Photo 6: View to northwest; note line of defoliated shrubs at least up to rail bridge abutment.
