**Photos 7-13: Snow Creek, Mile~45.7. 15 October 2017.**

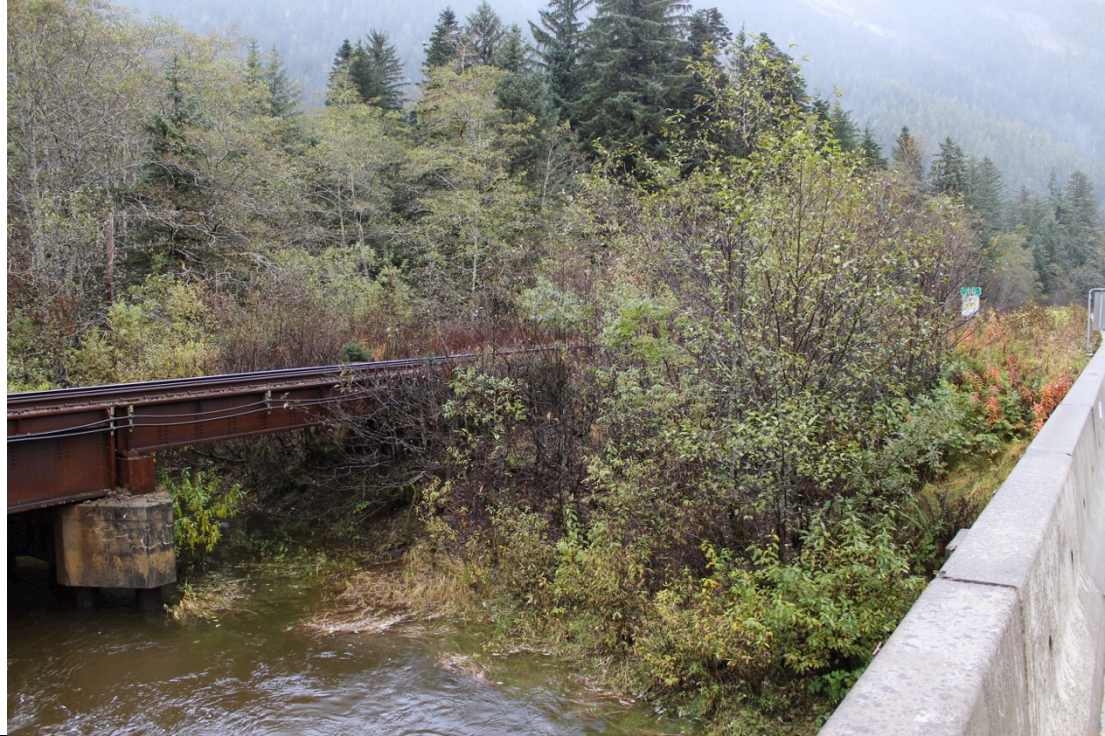
Photo 7. Upstream view to left bank, showing defoliated shrubs over wetted stream channel.

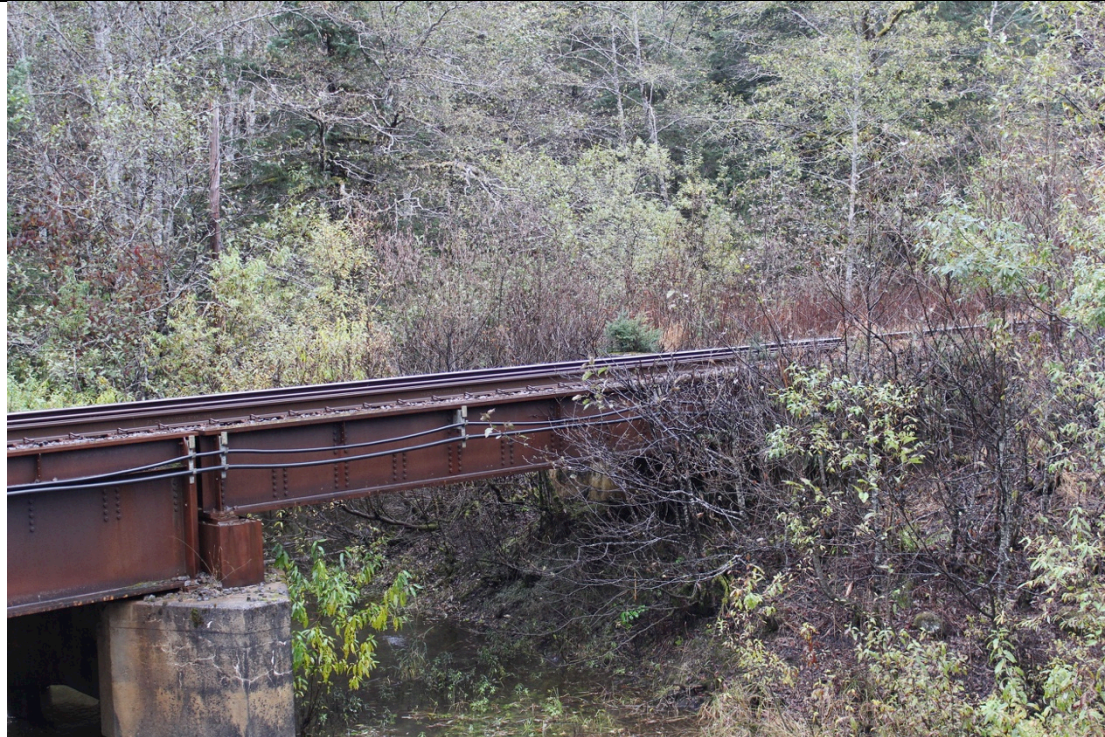
Photo 8. Defoliated red alder overhanging left bank downstream of rail bridge, and at least up to HWM of downstream left bank.

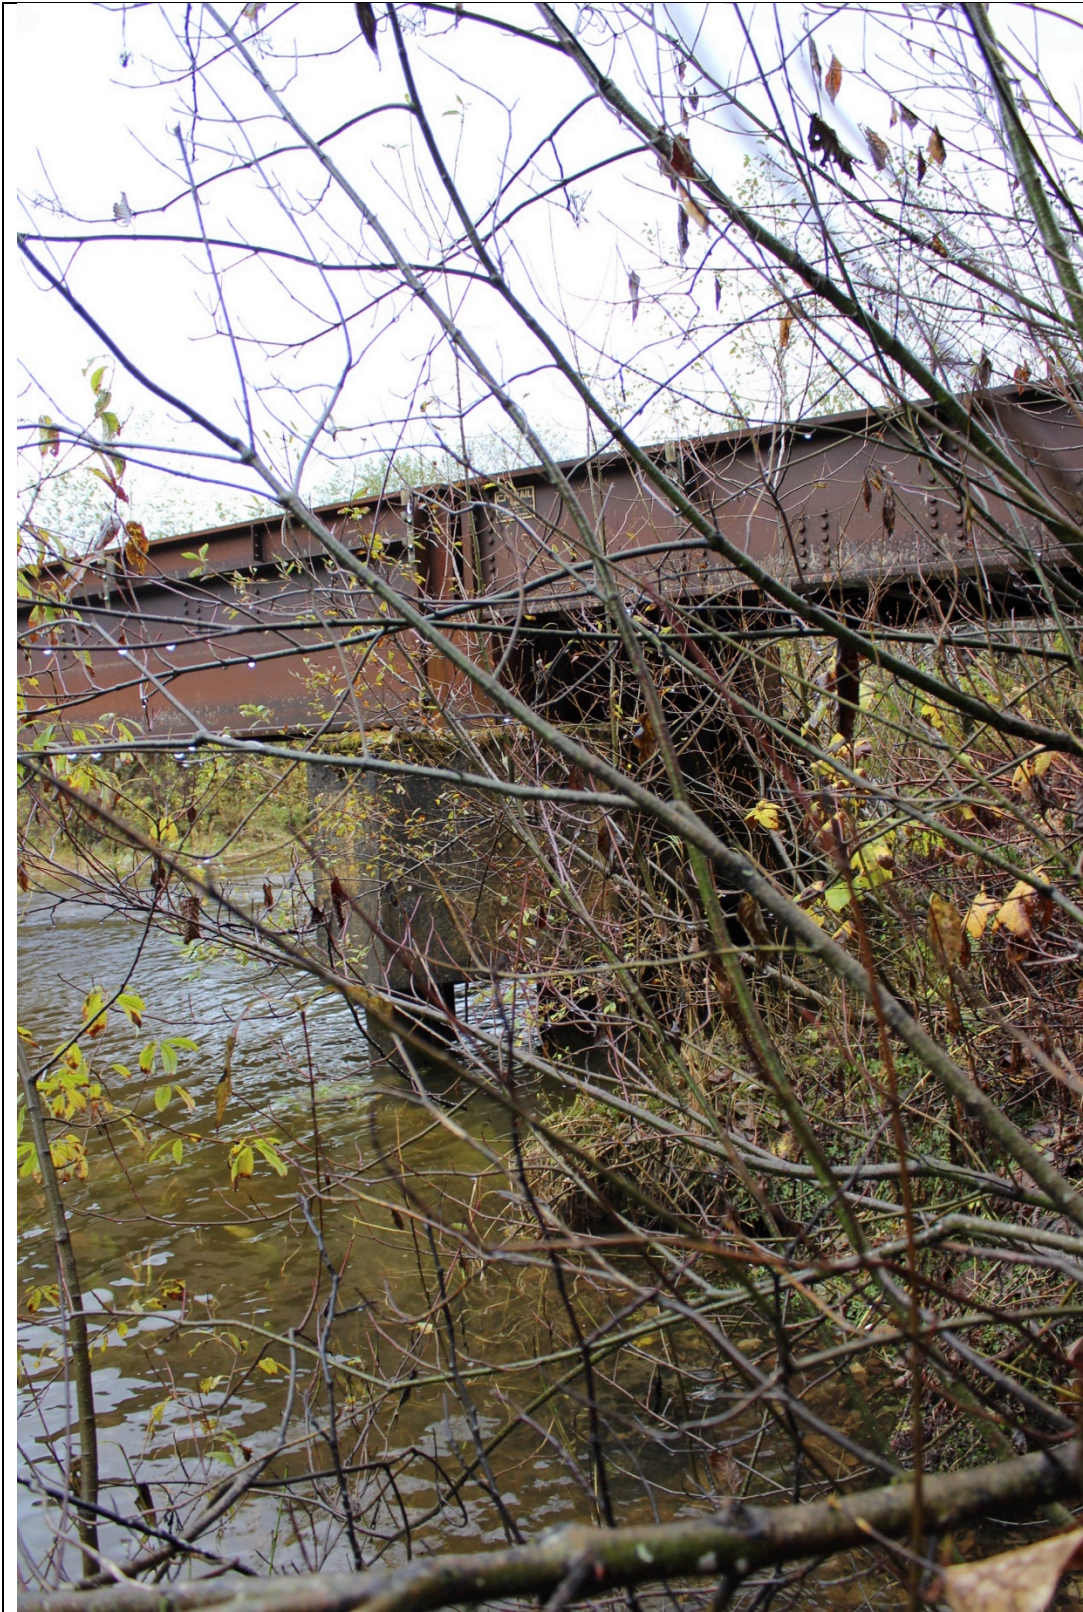
Photo 9. Downstream view of damaged Sitka willow, red alder and red-osier dogwood overhanging stream on right bank.

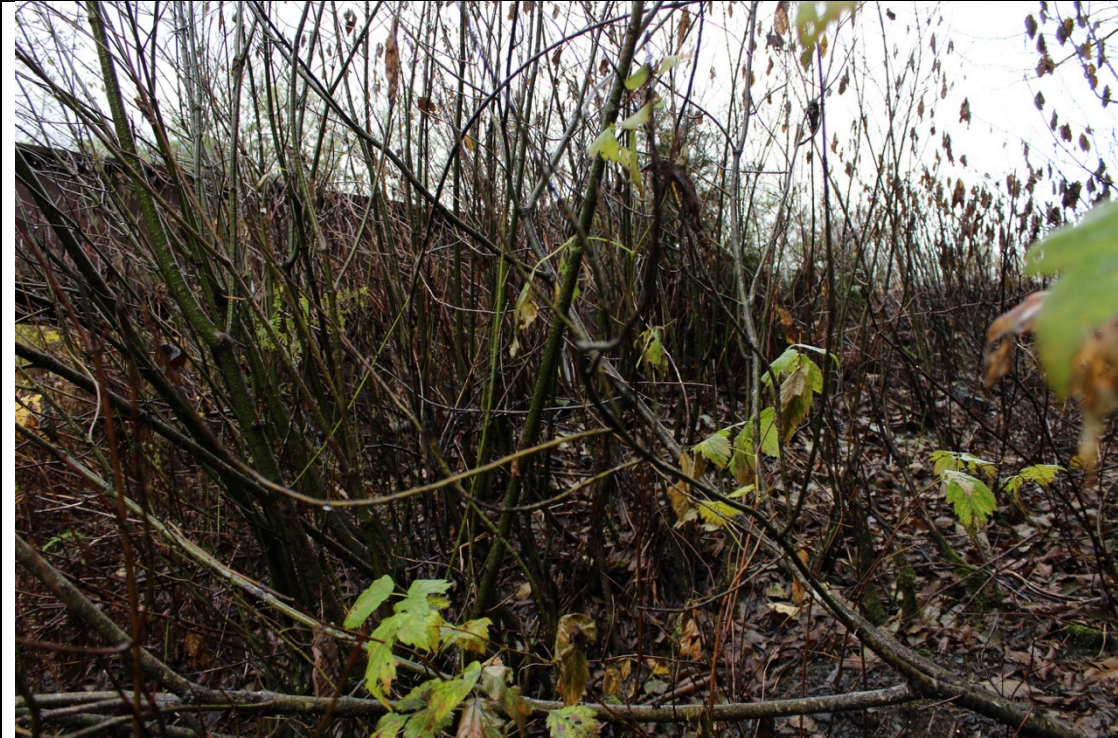
Photo 10. View of defoliated shrubs on upstream right bank.

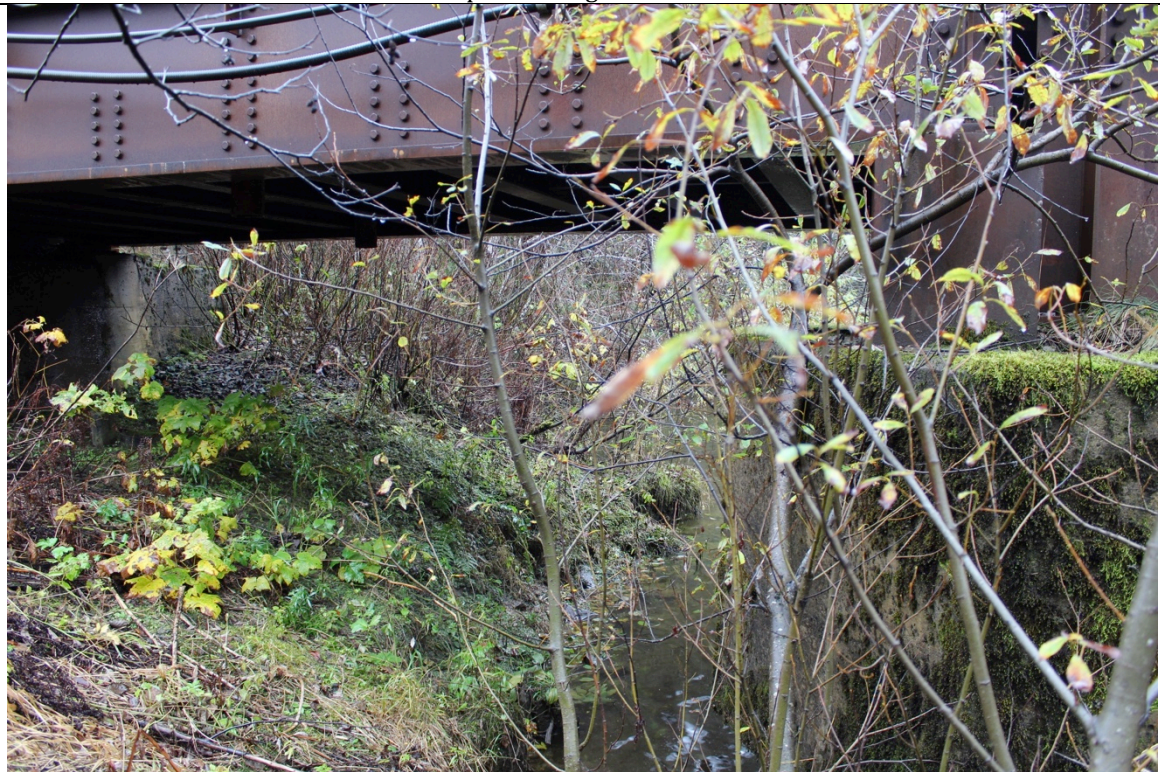
Photo 11. Upstream view of right bank at rail bridge, showing damaged vegetation to HWM on both upstream and downstream sides.

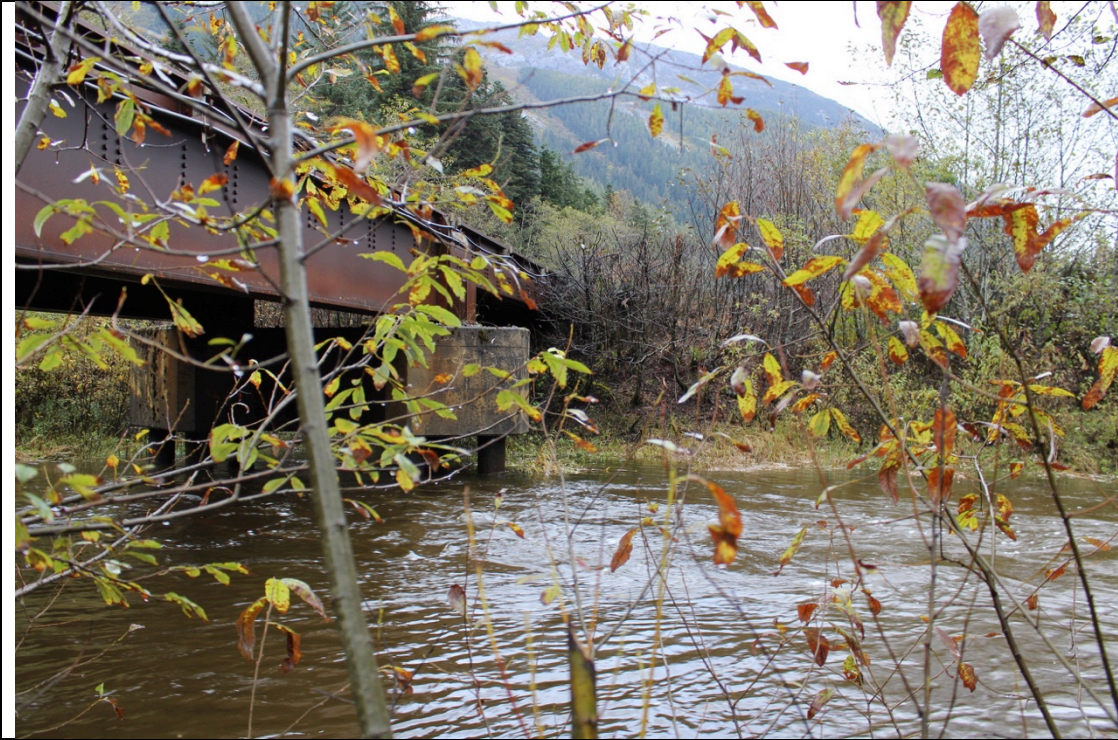
Photo 12. View to left bank, showing defoliated red alder up to and beyond HWM.
